Test Report No. 23372C

Sabetoflex roofing PIB Cold roof

Test methods for external fire exposure to roofs: Test method 2: Method with burning brands and wind. The test has been carried out according to CEN/TS 1187:2012 and is assessed to fully comply with ENV 1187/A1:2005.

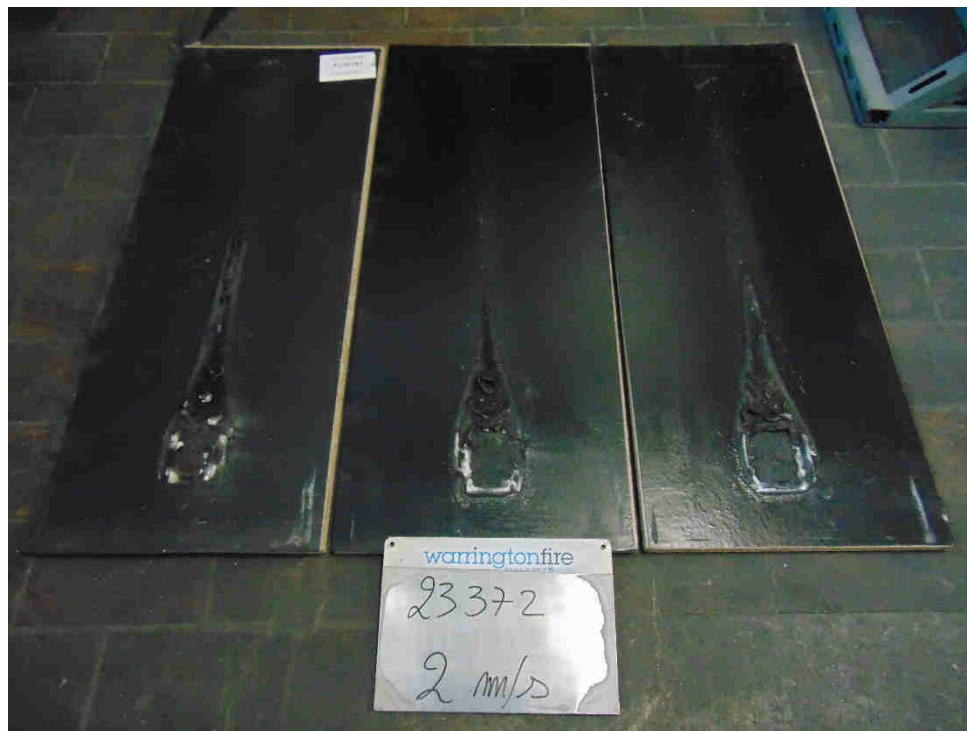
After test at 2 m/s

Results			
		Mean value	Max. value
2 m/s	Damaged length roof covering (mm)	350	430
	Damaged length substrate (mm)	350	430
4 m/s	Damaged length roof covering (mm)	337	510
	Damaged length substrate (mm)	337	510

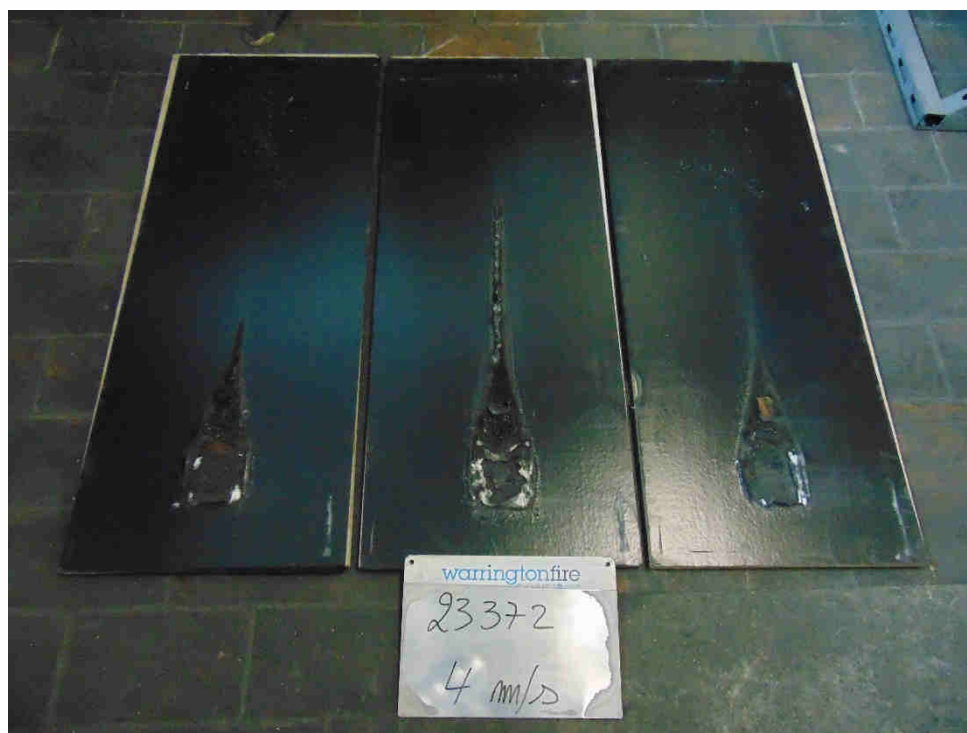
After test at 4 m/s
